# **SLOVENIAN INFRASTRUCTURE AGENCY**

## **Webinar on Road Marking**

# SPECIAL ROAD MARKINGS FOR MOTORCYCLISTS

### FIRST PILOT PROJECT - June/July 2016

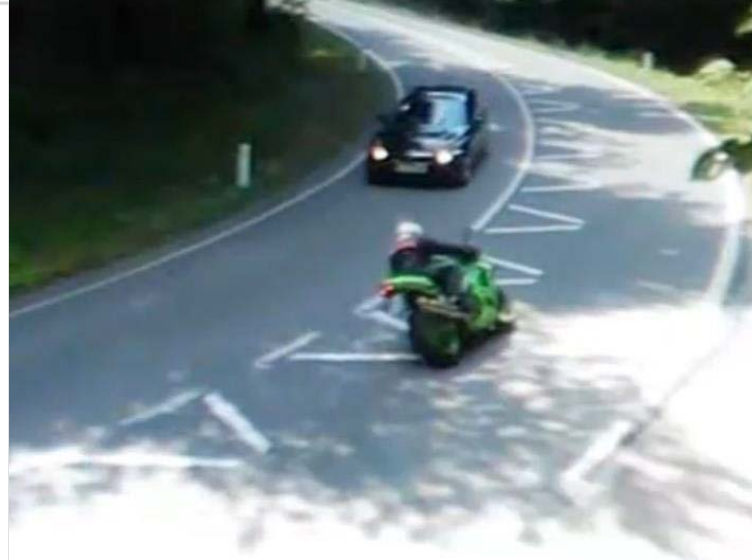
Monitoring učinkovitosti izvedenih ukrepov  
za izboljšanje prometne varnosti  
na DC R3-643/1436,  
med km 4,300 in km 8,600 (15 krivin)

Following the implementation of the special motorcycle road markings, motorcyclists generally adopted a safer riding position and trajectory through curves, maintaining a greater distance from the centerline and remaining within their lane more consistently. As a result, encroachment into the opposing traffic lane decreased, indicating a positive effect of the markings on rider behavior, lane discipline, and overall road safety.

Furthermore, the number of motorcycle crashes in the treated curves decreased by approximately 71%, confirming the effectiveness of the measure.

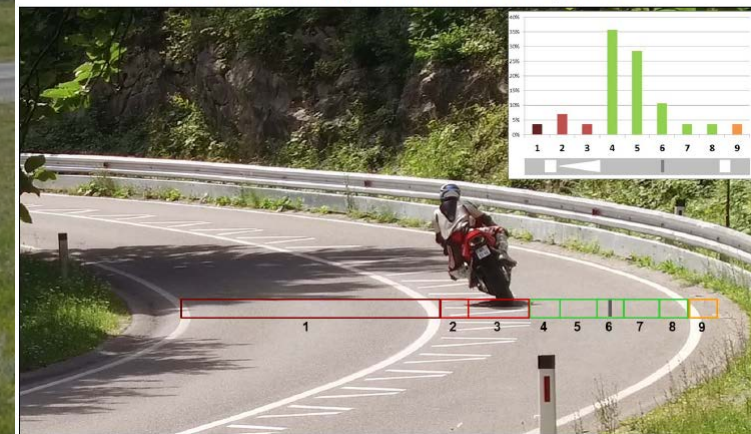
Slika 3.5: Primer delitve preseka krivine na devet segmentov

1. nasprotnosmerni vozni pas;
2. vozni pas: po/preko posebnih označbah – tik ob sredinski črti;
3. vozni pas: po/preko posebnih označbah – ostala površina;
4. vozni pas: tik ob posebnih označbah;
5. vozni pas: levo od sredine neoznačenega pasu ceste;
6. vozni pas: po sredini neoznačenega pasu ceste (med označbami in robno črto);
7. vozni pas: desno od sredine neoznačenega pasu ceste
8. vozni pas: ob desnem robu smernega vozišča;
9. vozni pas: robni pas.
